HYDRO-PORT'94

International Conference on Hydro-Technical
Engineering for Port and Harbor Construction
October 19 - 21, 1994, Yokosuka, Japan

Control of Littoral Drift in Caldera Port, Costa Rica

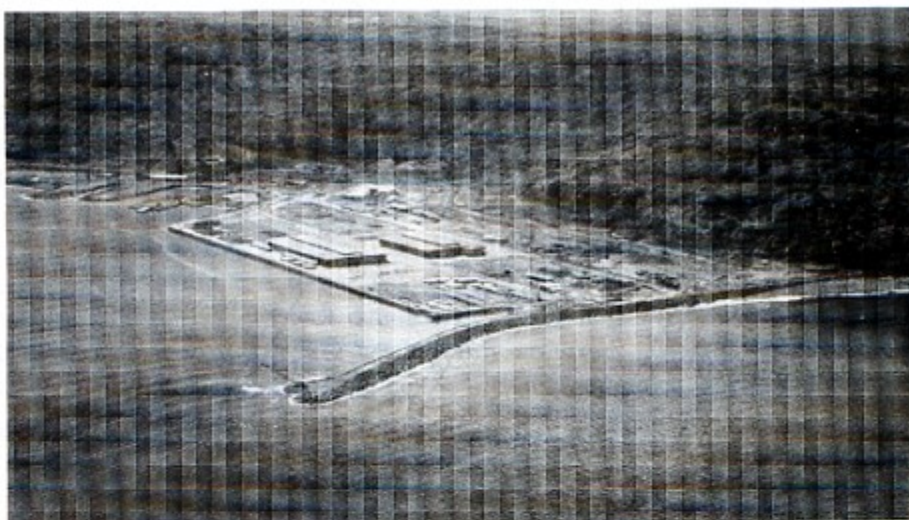
Photo 1 Caldera Port in 1981.

angle, ever since its initial construction in 1974 there has been a process of sedimentation going on at the west sea side of Caldera Port, where New Beach has been formed as seen in Photo 1. New Beach has kept growing and in 1981 the excess sand began to be transported around the tip of breakwater into the port (see Figure 5).

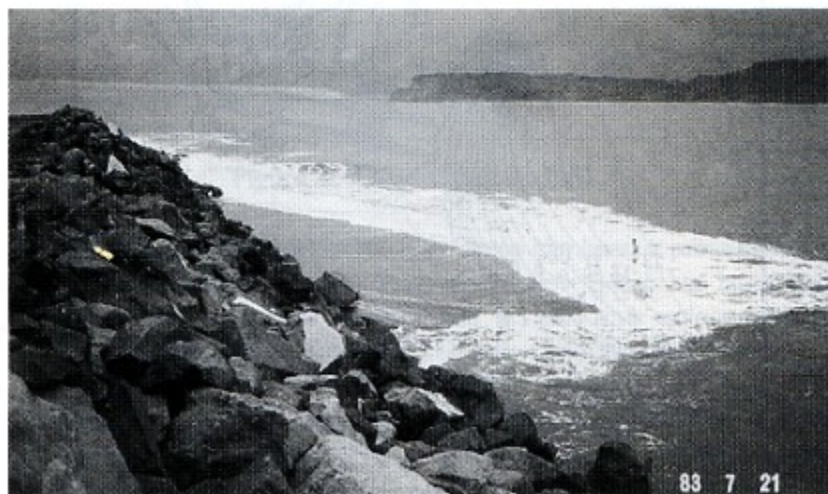
Photo 2 New Beach Junior on the 21st July 1983.

behind the breakwater as shown in Figure 6 and in Photo 2. In order to make fluorescent sand tracer, we took the sand from New Beach Junior, of which diameter is about 0.2 mm. During an attenuation of this storm, on the 26th July, when the breaking waves still diffracted and propagated along the inner side of the breakwater, we injected fluorescent sand tracers of 200 kg at the point near the base of wing-breakwater, which is indicated by an asterisk in Figure 6. On the next day, the sands were sampled from the surface of New Beach Junior. Figure 7 shows a distribution of fluorescent sand tracer, which well agreed with the topography of New Beach Junior. Then, it is inferred that the sand transported from New Beach around the tip of breakwater into the port was carried in suspension farther along the inner side of breakwater to New Beach Junior where the turbulence of diffracted waves well diminished. From here on a subsequent slow process of sand dispersion toward the first berth surely occurred. That is because the scale of New Beach Junior gradually decreased by the action of diffracted waves and disappeared by the beginning of August.

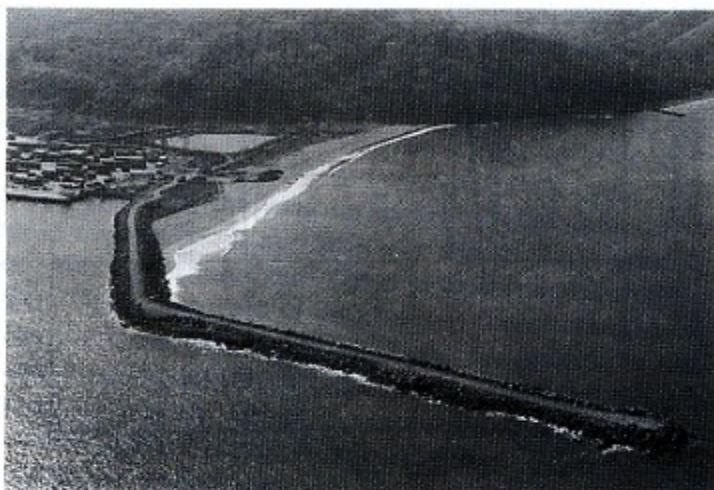
Photo 3 Wing-breakwater in 1993.

The wave on the days of 27th, Saturday, and 28th, Sunday, July were extremely large. According to an eyewitness, a large overtopping occurred over the wing in the reach of about 100 meters from the wing tip. The rubble stones located 85 meters from the wing tip and above L.W.L. were scattered into the lee side area. Also in this disaster, a reach of 56 meters was restored with other stones in a short period. The total length of wing is 272 meters at present (see Photo 3).

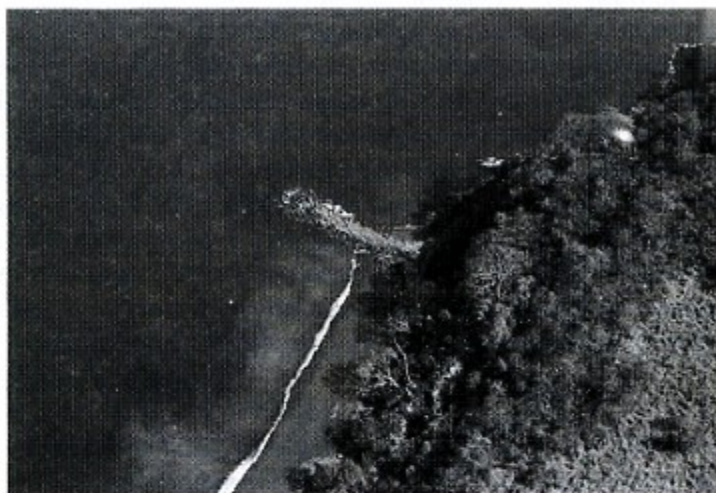
Photo 4 Small jetty located between New Beach and Corralillo Beach.
